**KIA Picanto**  
Hatchback, 5 door  
From September 2023

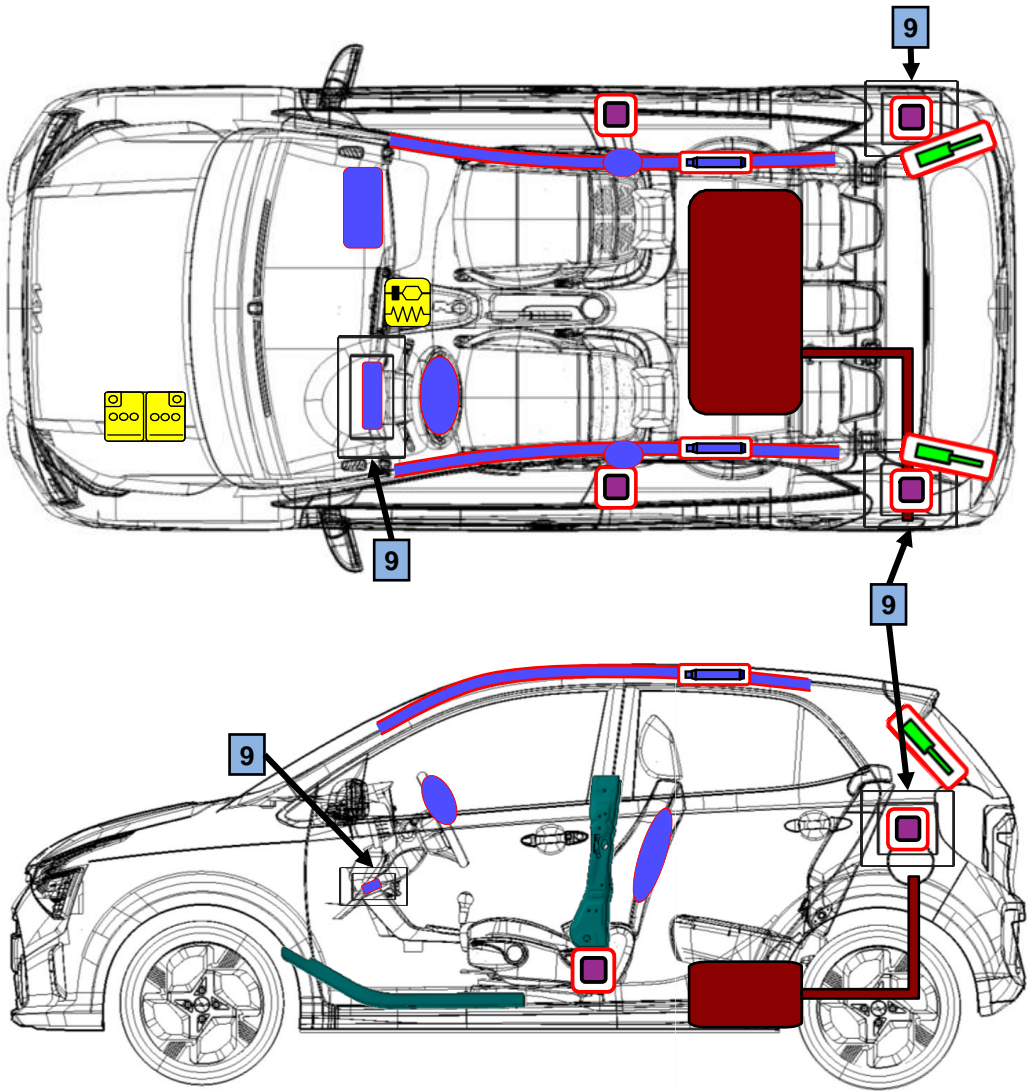
Airbag		Stored gas inflator		Seat belt pretensioner		SRS control unit		Fuel tank
	Battery low-voltage		Gas strut / Preloaded spring		High strength zone		Zone requiring special attention

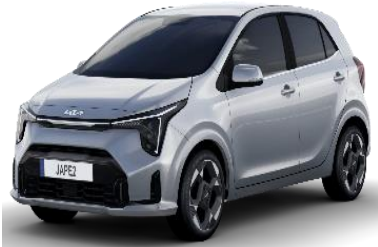
Pull the release lever to unlatch the hood.

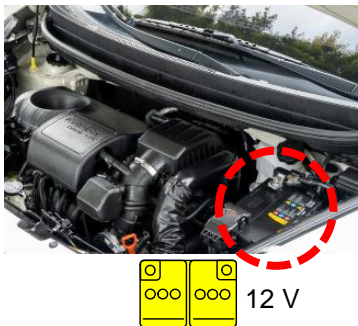
Raise the hood slightly, push the secondary latch up (1) inside of the hood center and lift the hood (2)

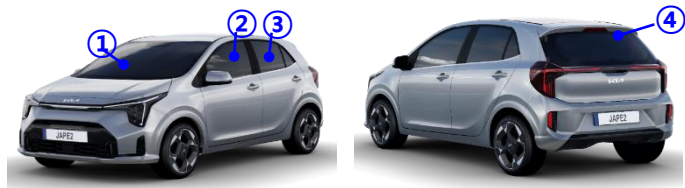
Glass:

①	Laminated
②,③,④	Tempered

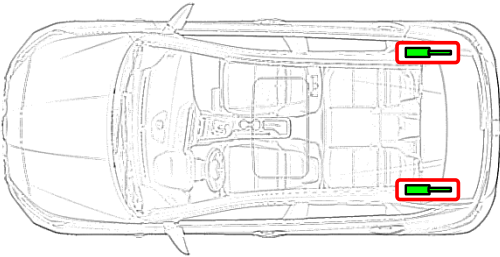
**Gas strut!**

Risk of missile effect of hood and tailgate.

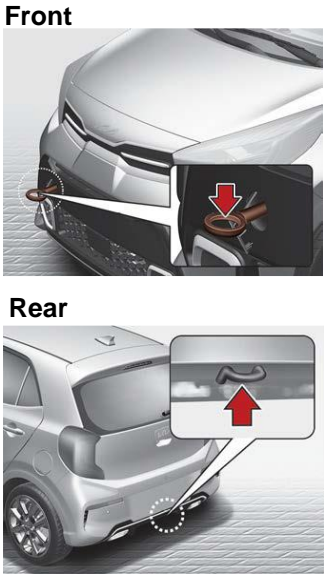
Towing hook is located in the tool case in the tailgate

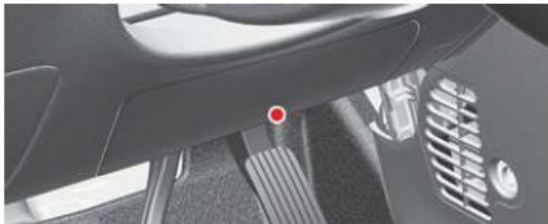
Optional equipped with Driver Knee Airbag

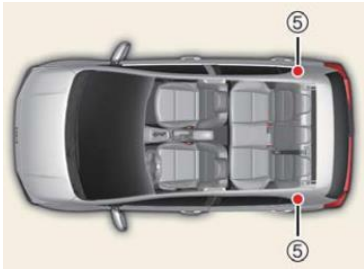
Optional equipped with Rear retractor pre-tensioner
